ENVIRONMENTAL IMPACT ASSESSMENT OF THE WATER AND SANITATION CONDITIONS IN THE TEMPORARY SETTLEMENTS OF TAMIL NADU 6 MONTHS AFTER THE TSUNAMI

Field assessment report of

Auroville Water Harvest and RedR India

June 2005

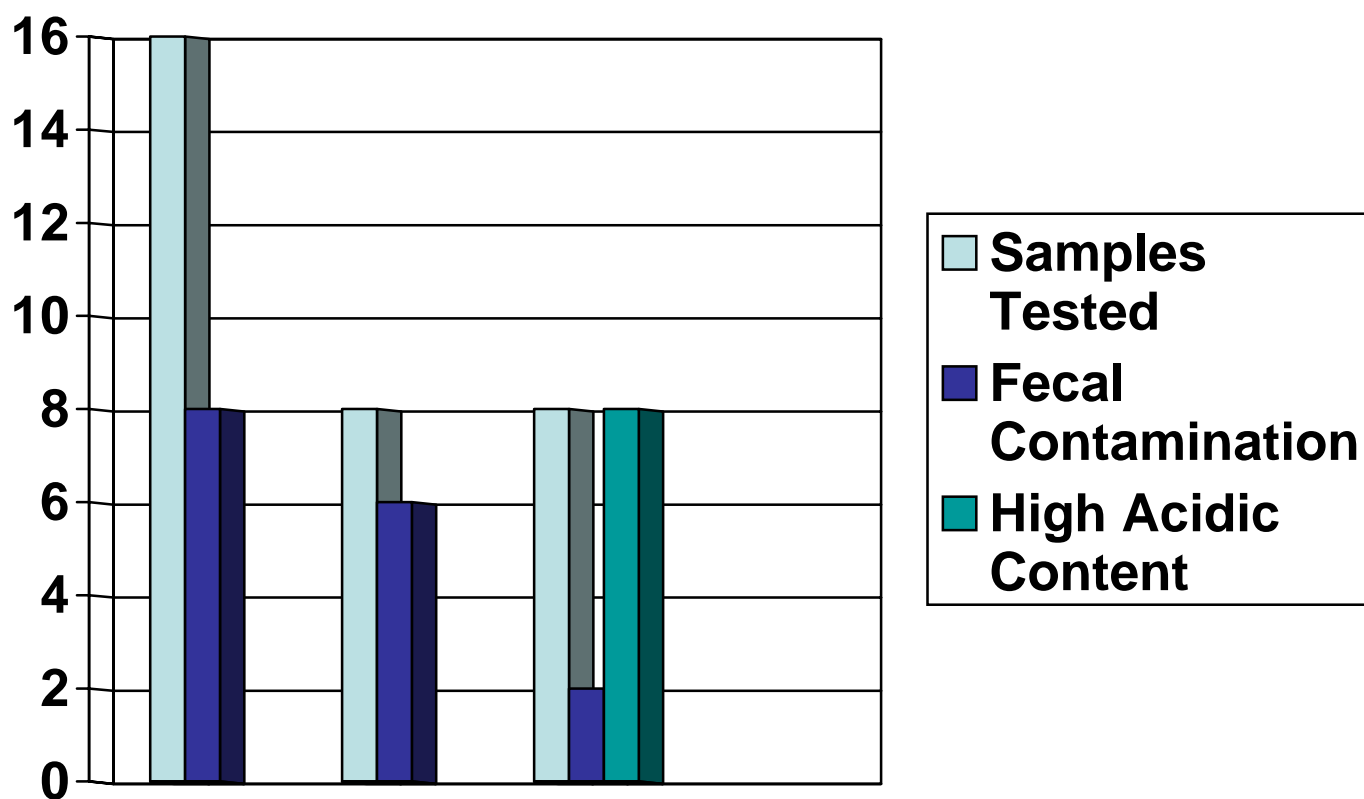
Water Sample Testing Results

Point of concern is that the water sample from the tank at the Velankanni Konartupu Settlement (Nagai), which is said to provide shrine water to pilgrims, was found to be contaminated. It would be worth to note that tanker samples tested at Aryanatu Street (Nagai), Anthonyar Nagar (Tuticorin) and Kottilpadu (Nagercoil) did not show traces of fecal contamination but those samples collected from the houses, which used this tanker water, indicated definite traces of such contamination. This occurs from improper secondary storages without taps/covers or unhygienic usage at household level.

Very low pH (4-6) found in ALL the samples collected in Kottar Social Service Society intervention area indicate high acidity indicating the presence of corrosive metals in water which will be detrimental to health in longer run. Also in Nagercoil area the salinity of drinking water was not as much a problem, pre-tsunami, as it is now. The Team met the agency, which has been awarded contract for installing water filters in Nagercoil. However these filters have UV system linked to slow sand filters (with backwash). Normally such filters could be effective in tackling the fecal contamination, turbidity, odour etc but not useful in removing the salinity of water or even increasing the pH of the drinking water. Salinity could be reduced by Reverse Osmosis plants, which could not be a cost-effective option for the shelters. As aforementioned the salinity is bound to get diluted over a period of time, during and after monsoons.

- **It is recommended that the measures for inducing recharge of shallow groundwater aquifers (Roof Top Rainwater Recharge/Harvesting) to reduce the salinity gradually.**
